Situation Photo Log

Tuesday, February 5, 2013

Kalamazoo River / Enbridge Spill

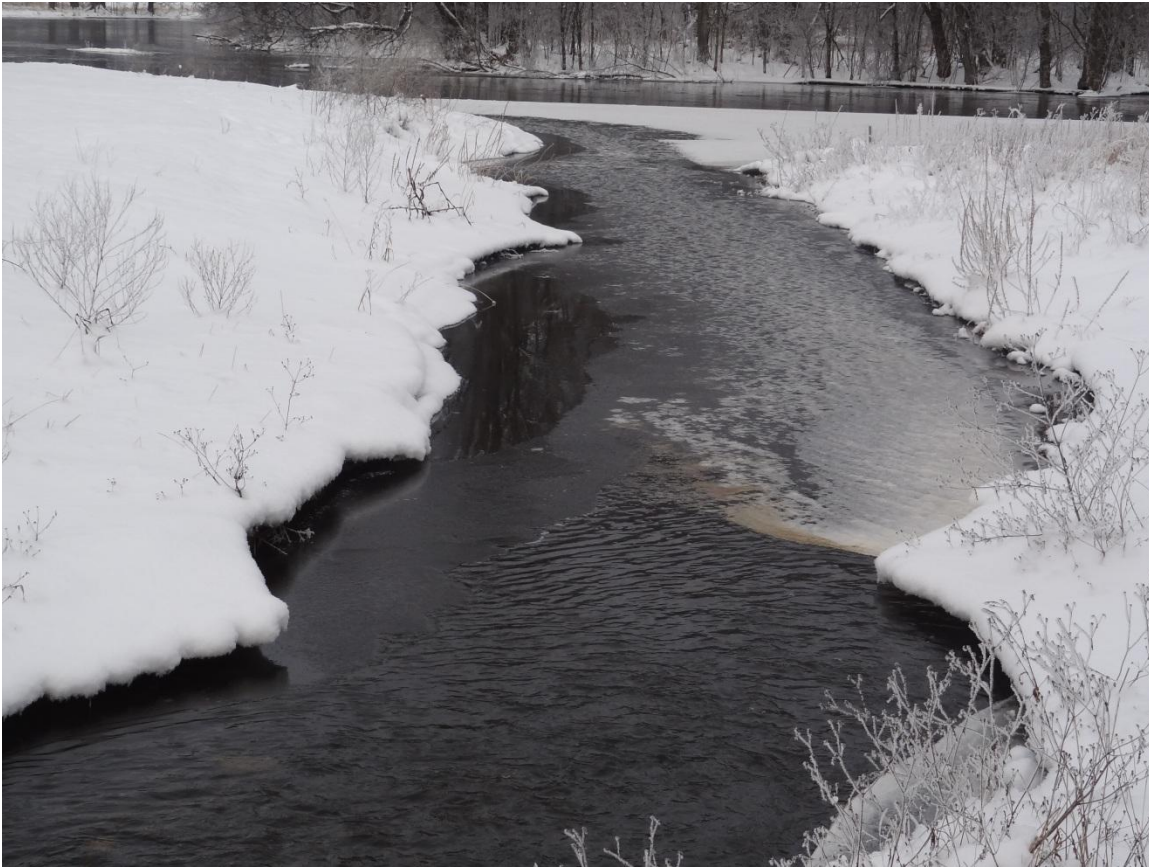
1. Talmadge Creek flowing to confluence observed icing conditions.

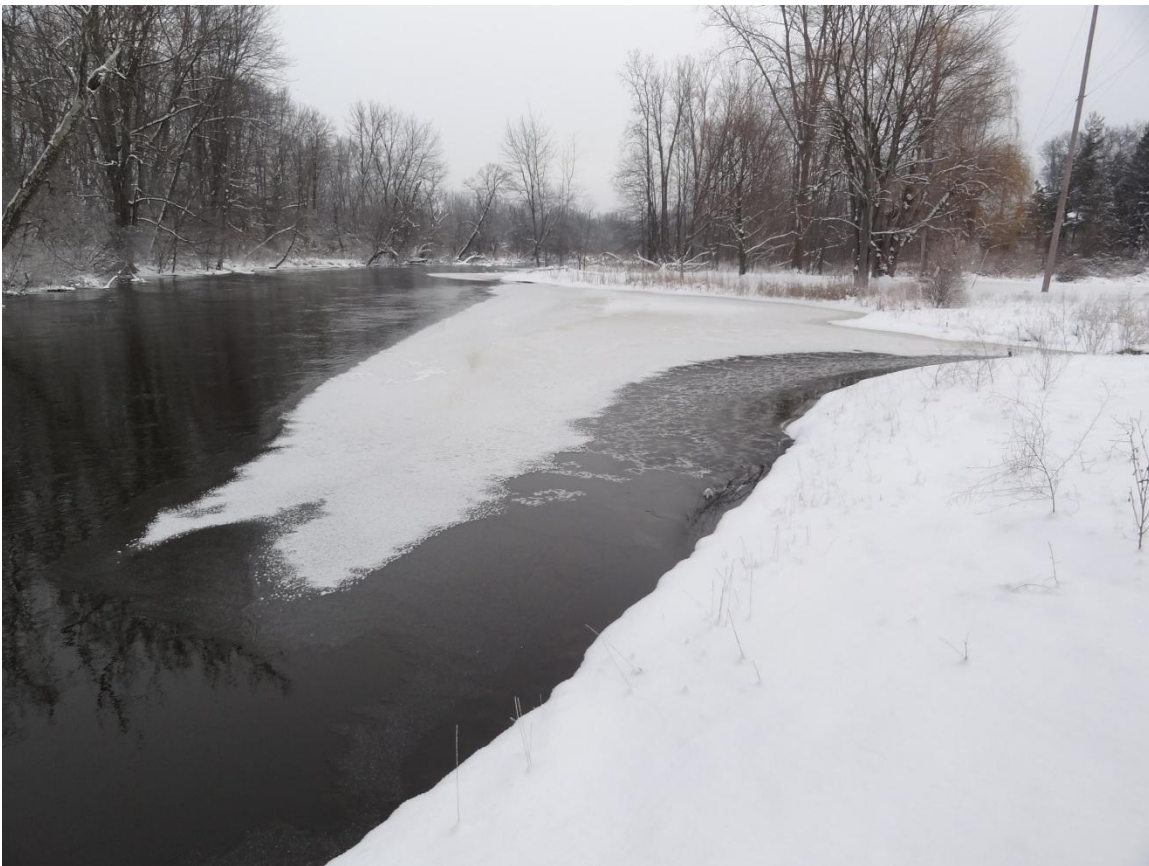
2. Confluence observed icing conditions.

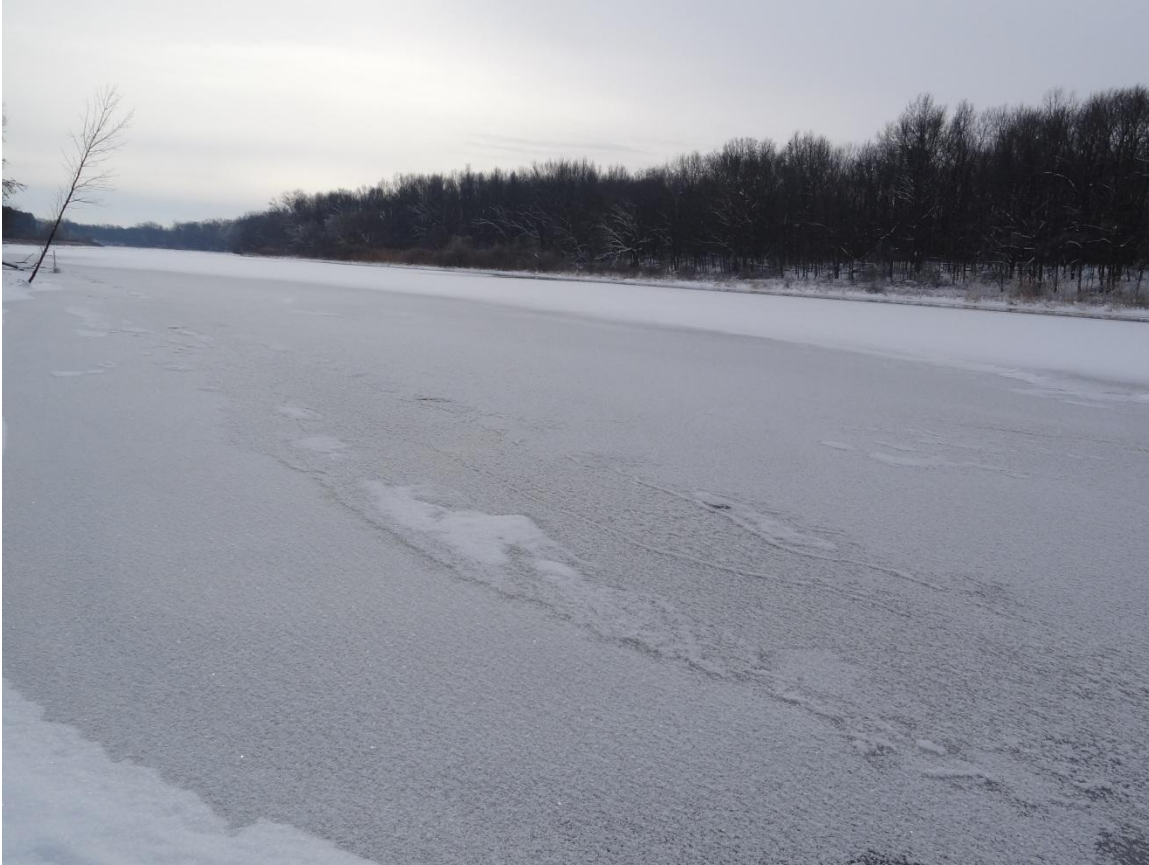
3. C0.4 Boat Launch observed river icing conditions.

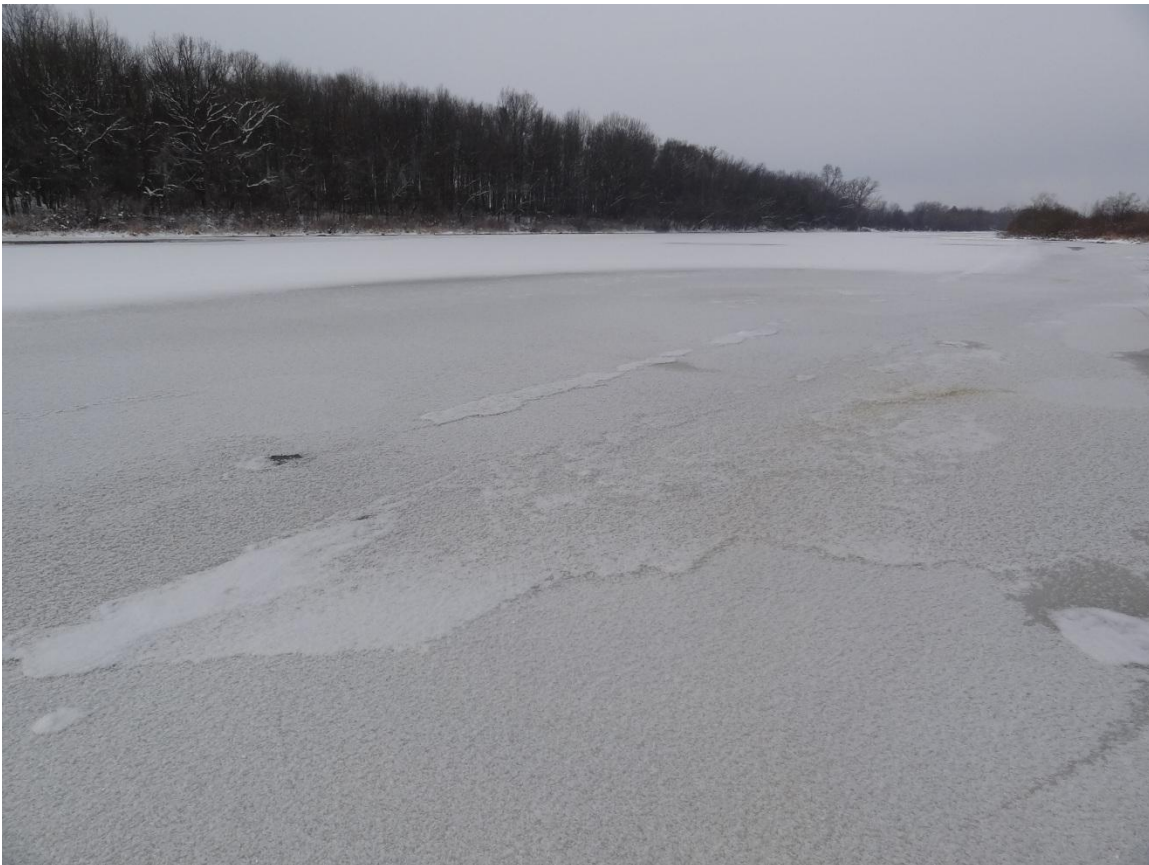
4. C0.4 Boat Launch observed river icing conditions.

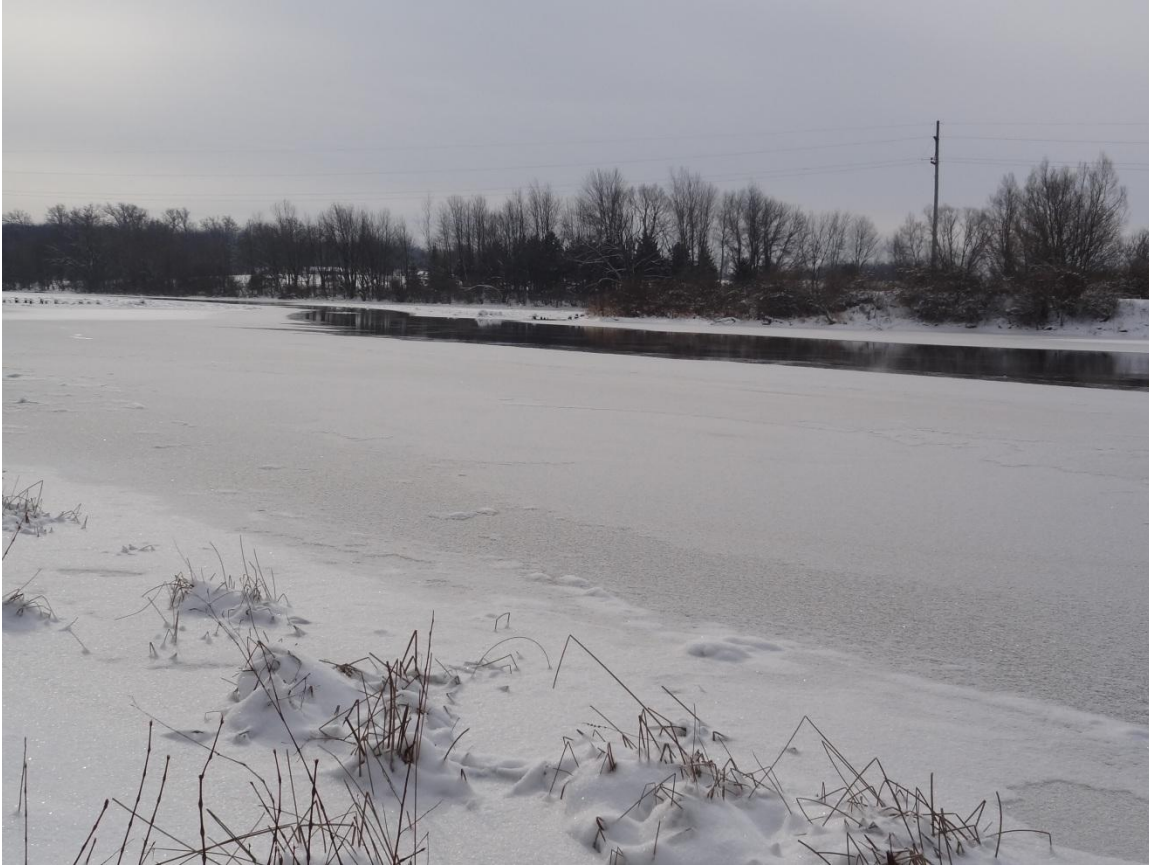
5. Ceresco Dam impoundment observed river icing conditions.

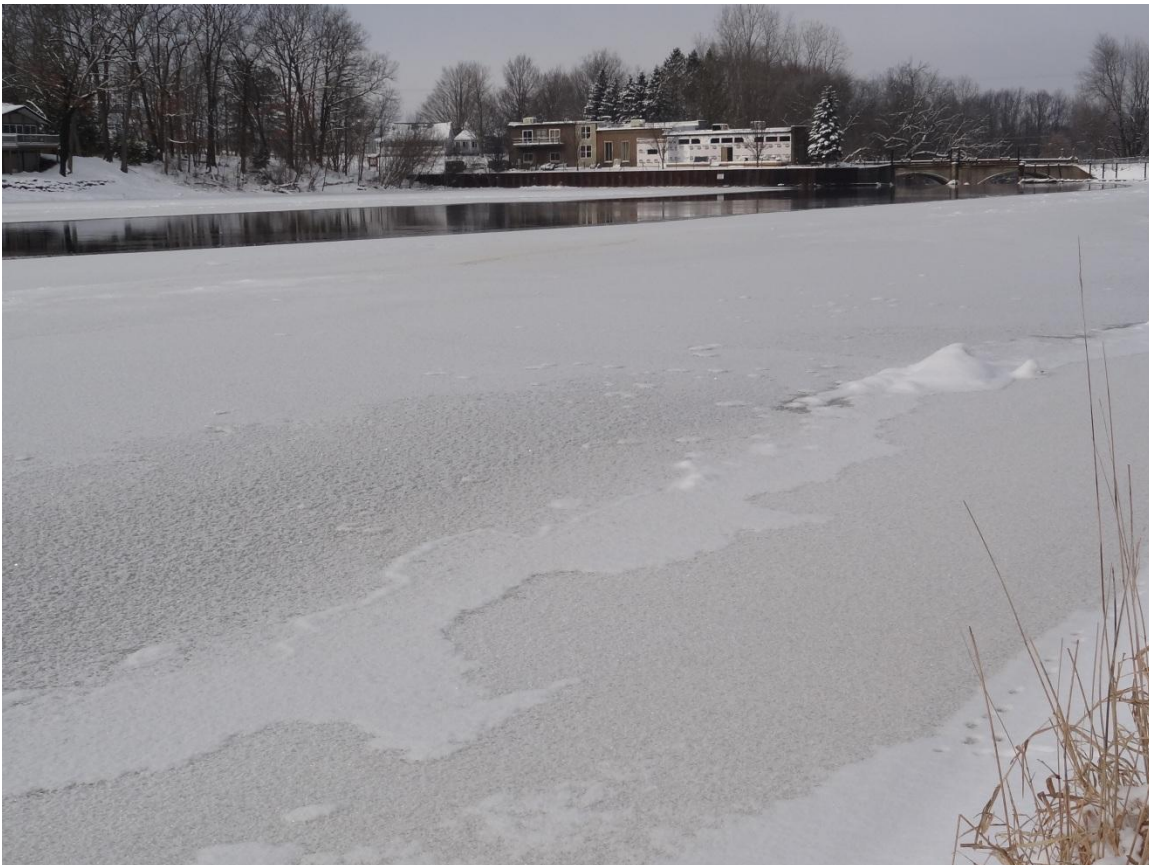
6. Ceresco Dam impoundment observed river icing conditions.

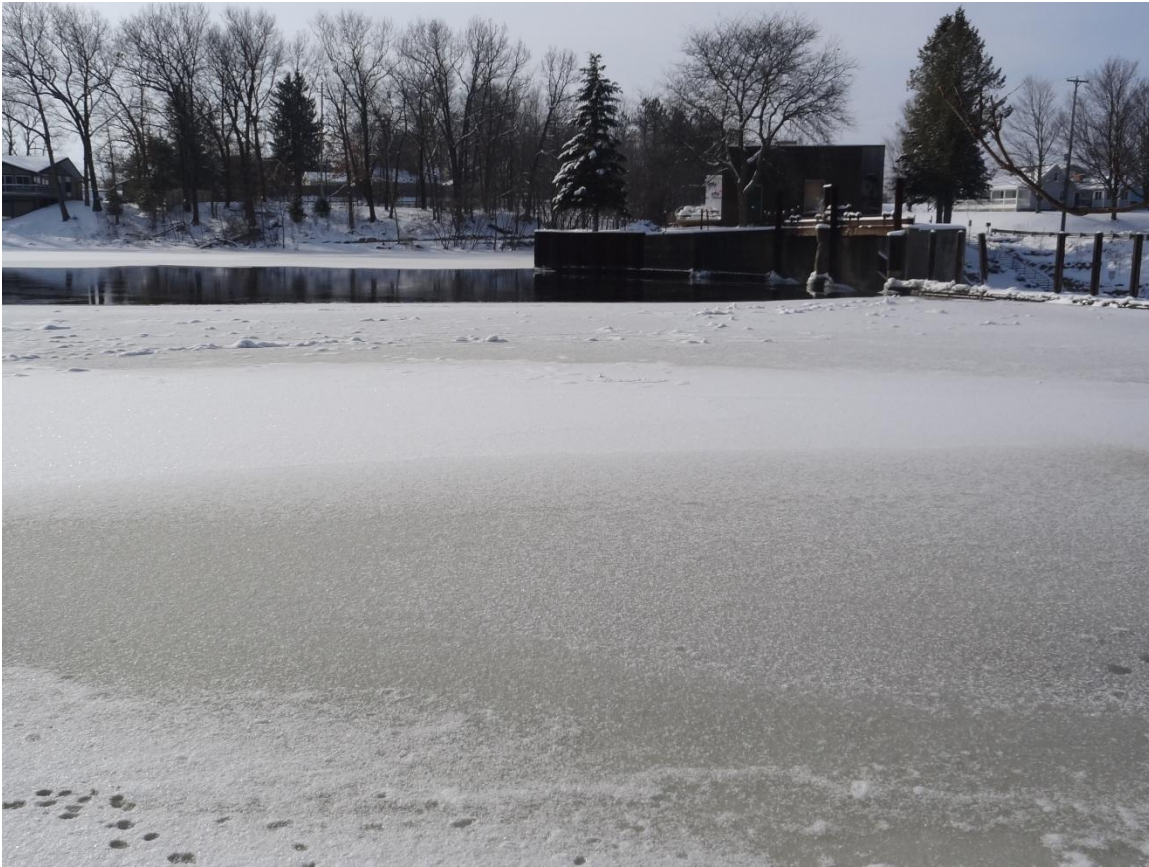
7. Ceresco Dam impoundment observed icing conditions.

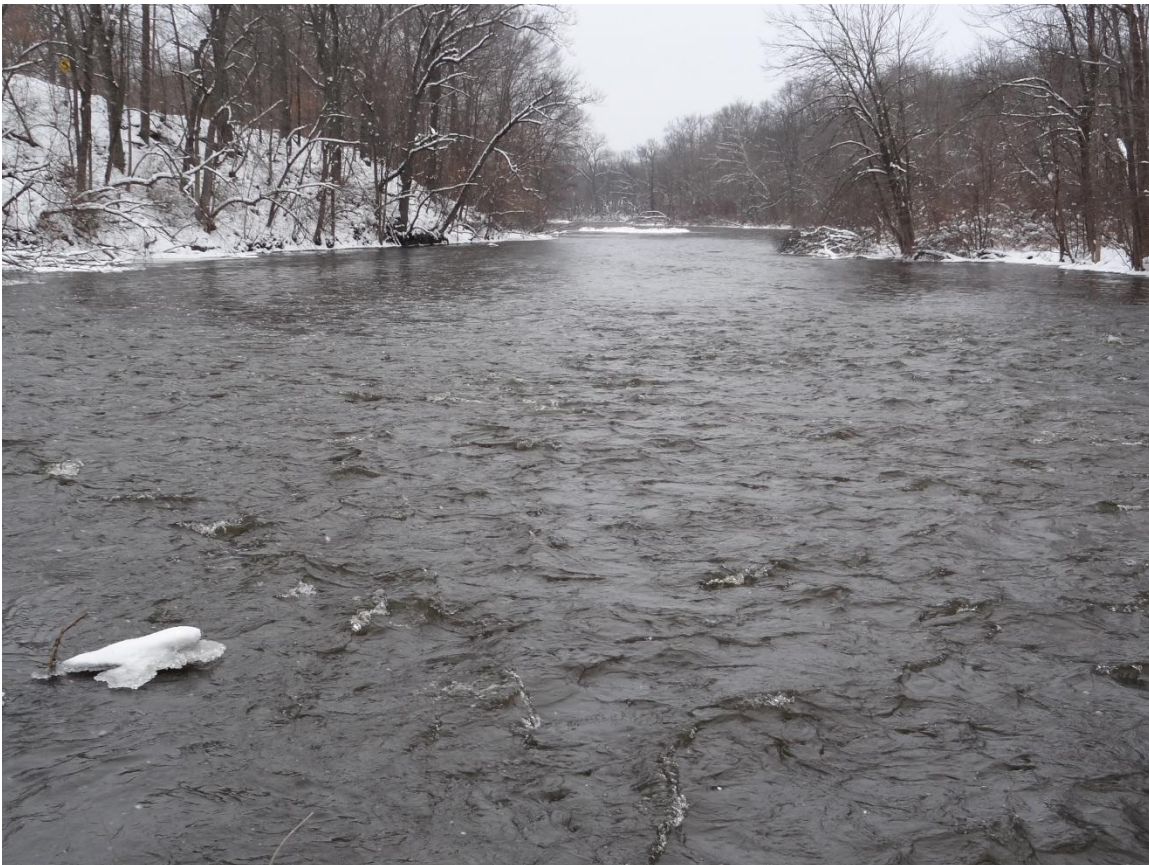
8. MP7.25 downstream from Angler's Bend observed river icing conditions.

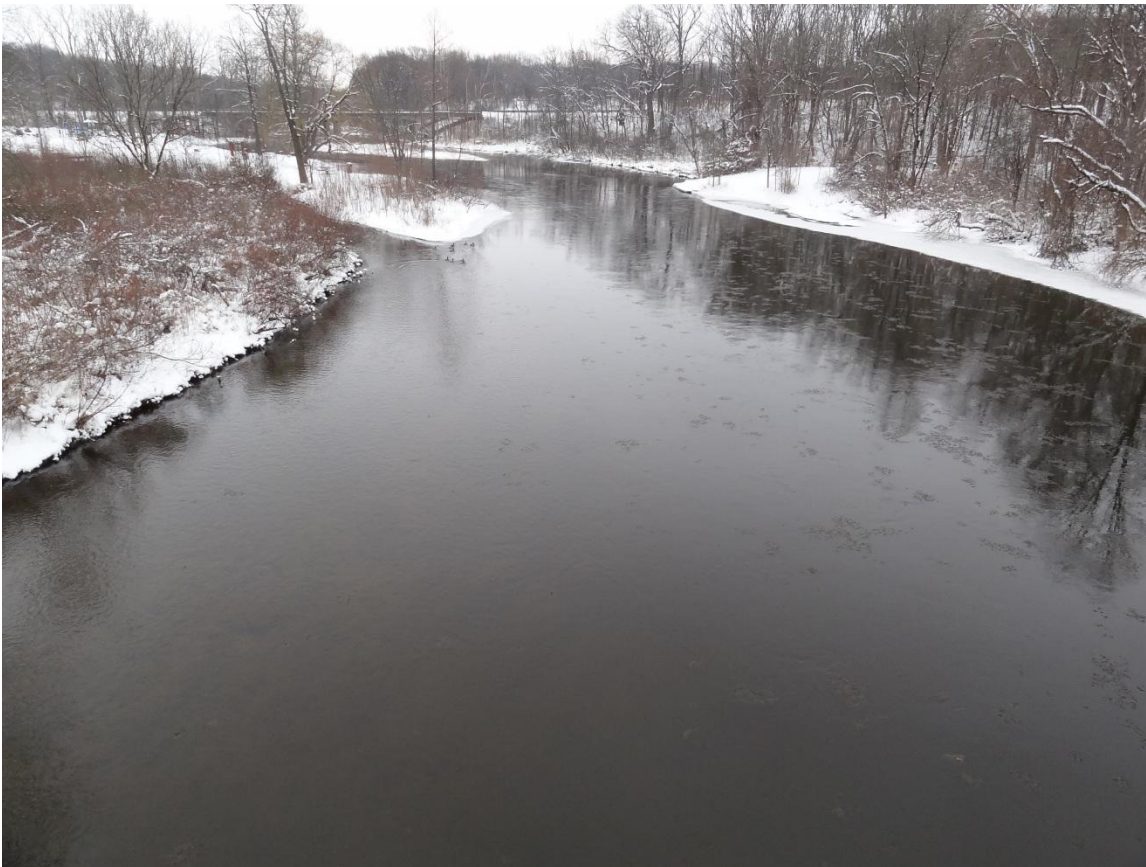
9. MP9.75 upstream from Wattles Road Bridge observed river icing conditions.

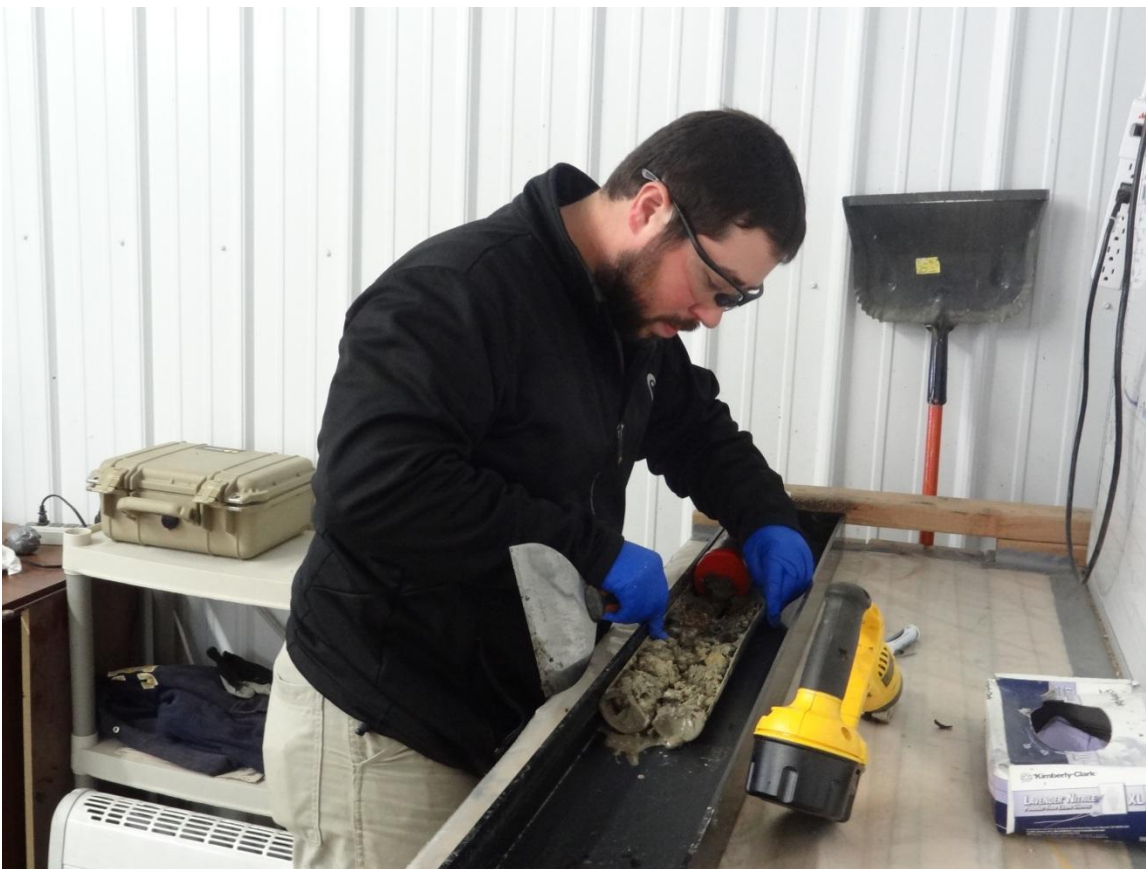
10. C3.2 Pole Barn observed core logging procedures.

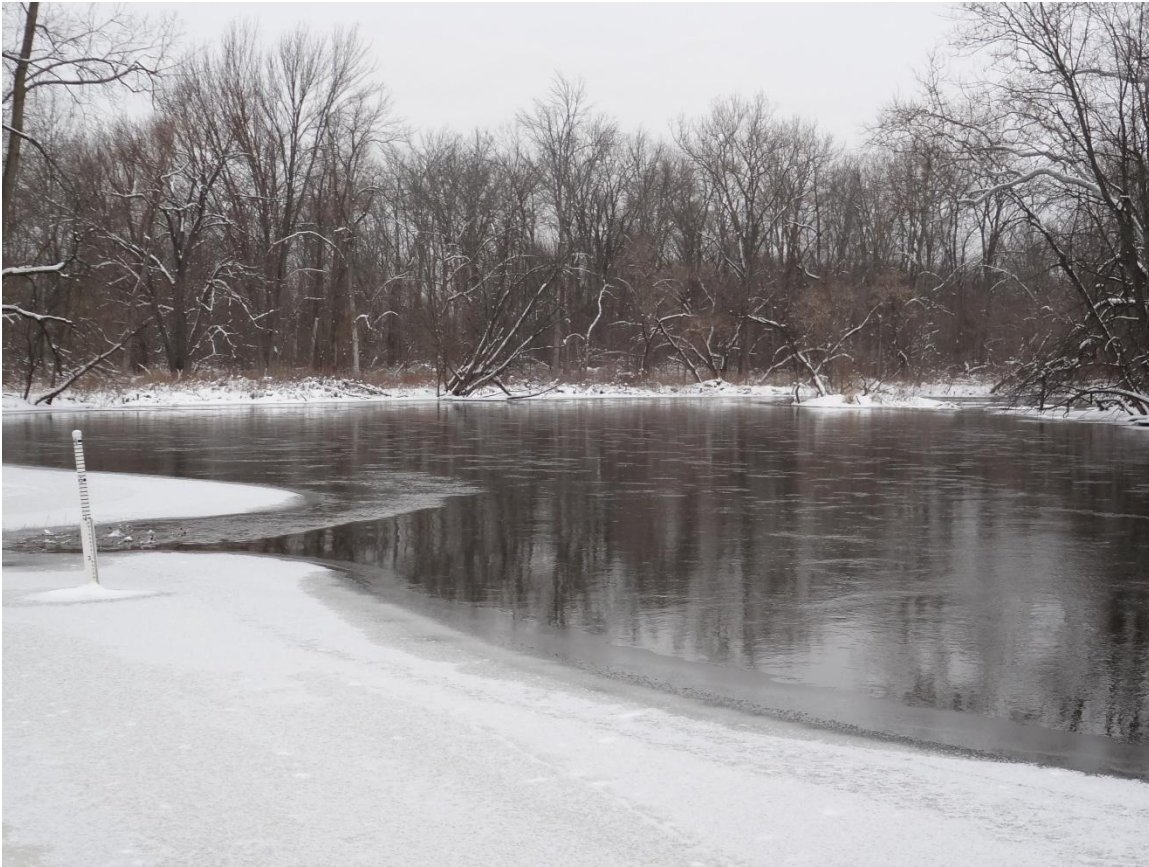
11. C3.2 Boat Launch observed river icing conditions.

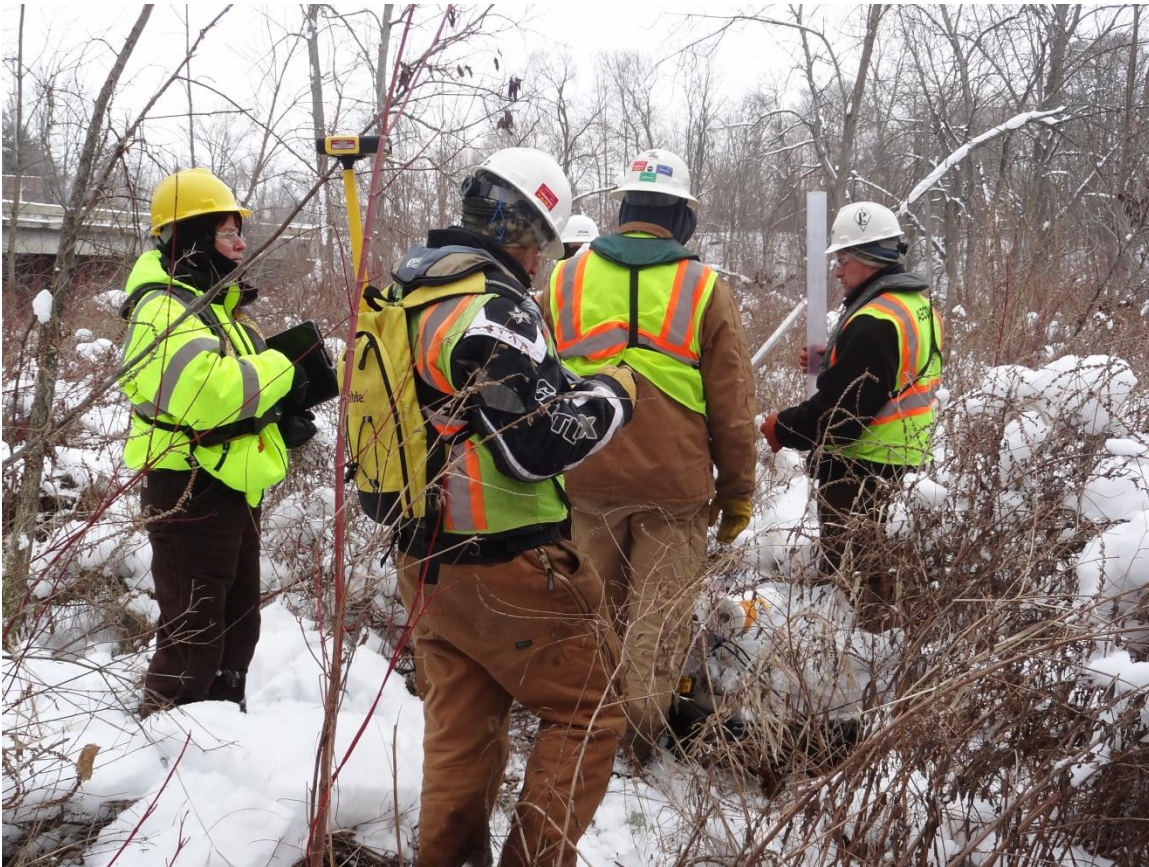
12. MP14.25 LDB observed RI team.

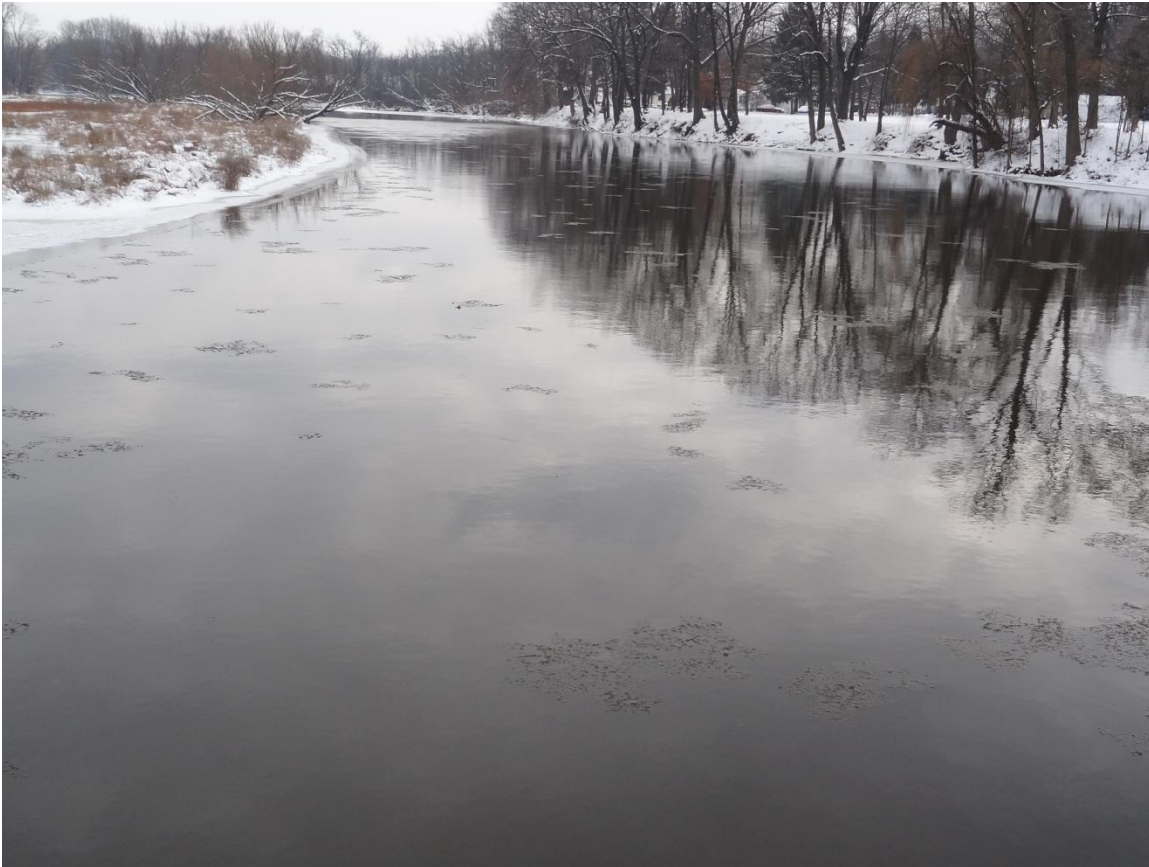
13. MP15.25 South Mill Pond observed river icing conditions.

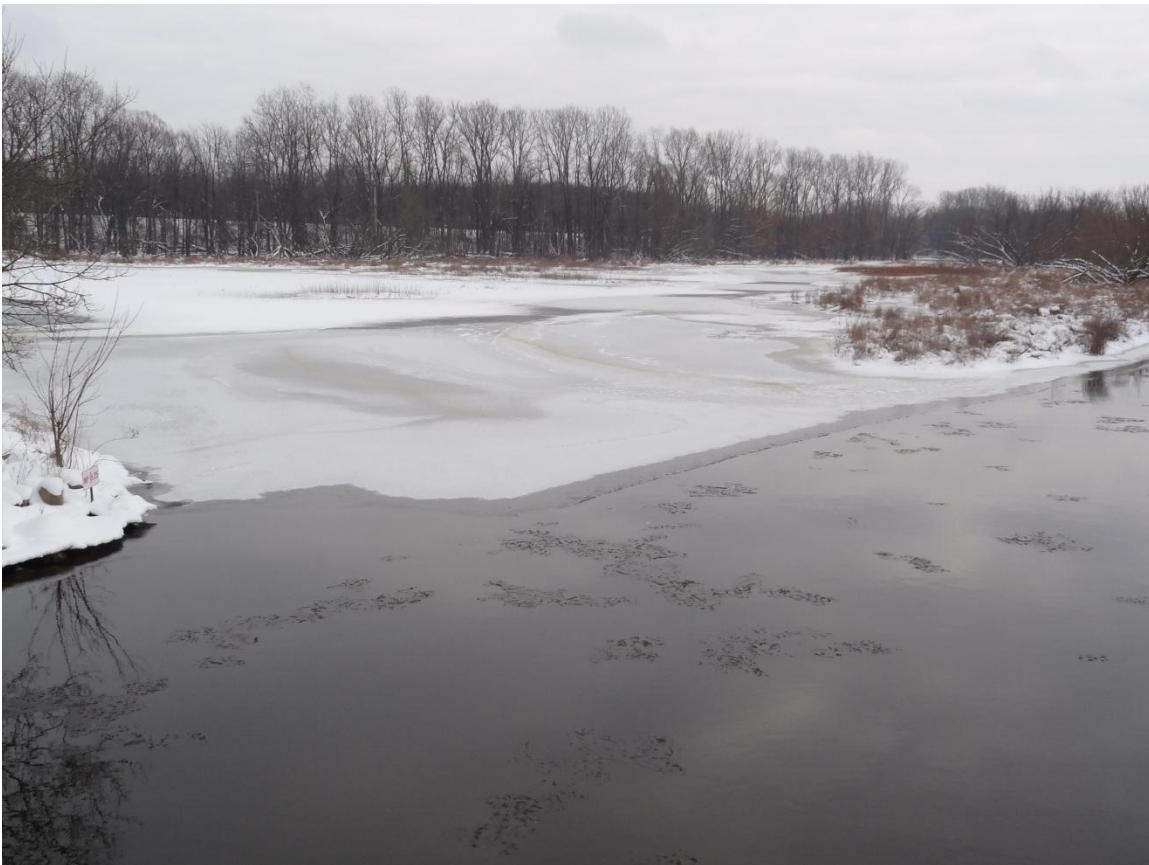
14. MP15.25 South Mill Pond observed back water icing conditions.

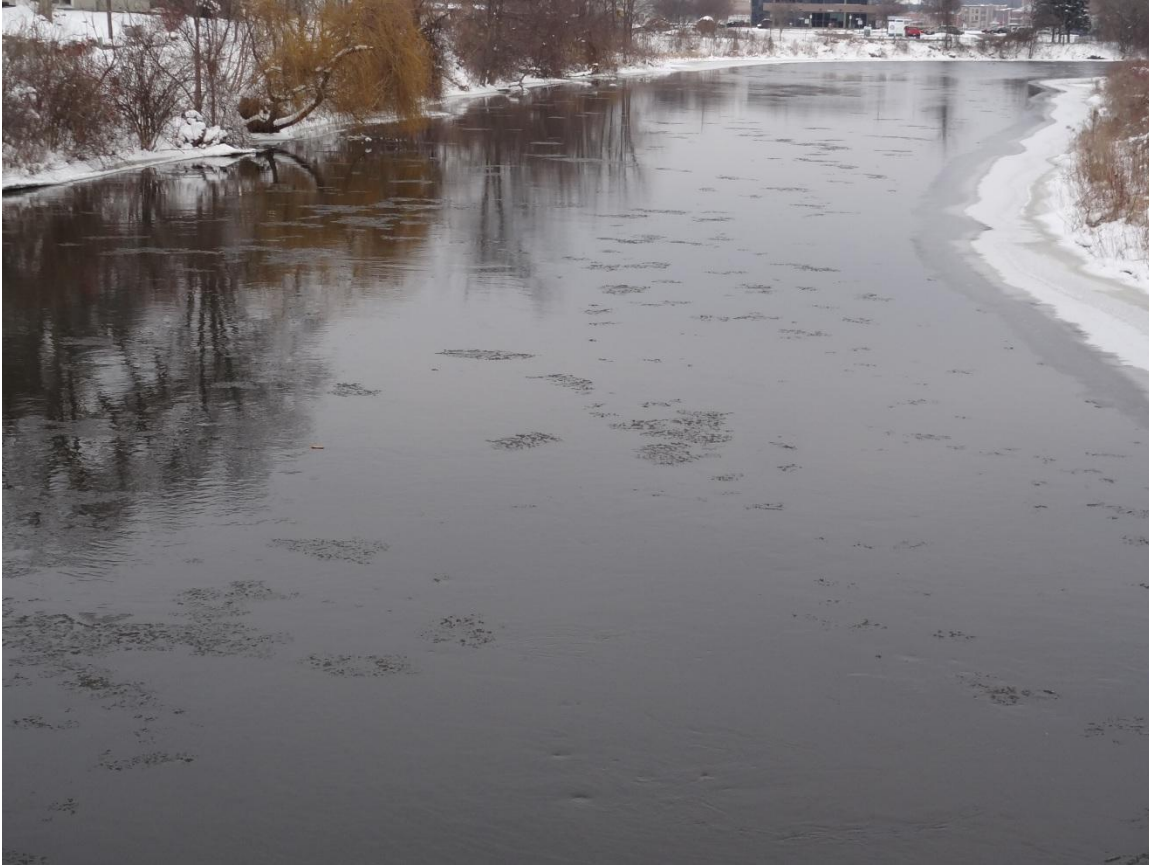
15. MP15.50 North Mill Pond observed river icing conditions.

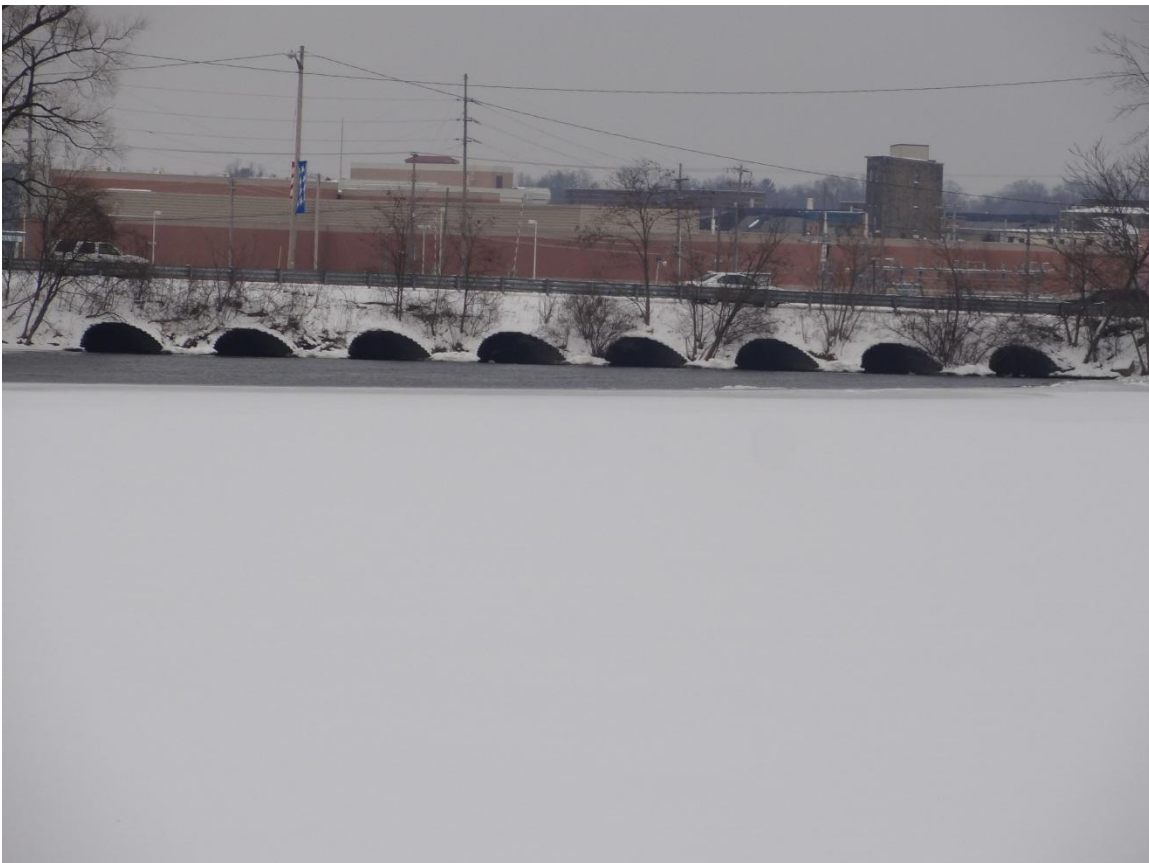
16. MP15.65 North Mill Pond culverts observed icing conditions.

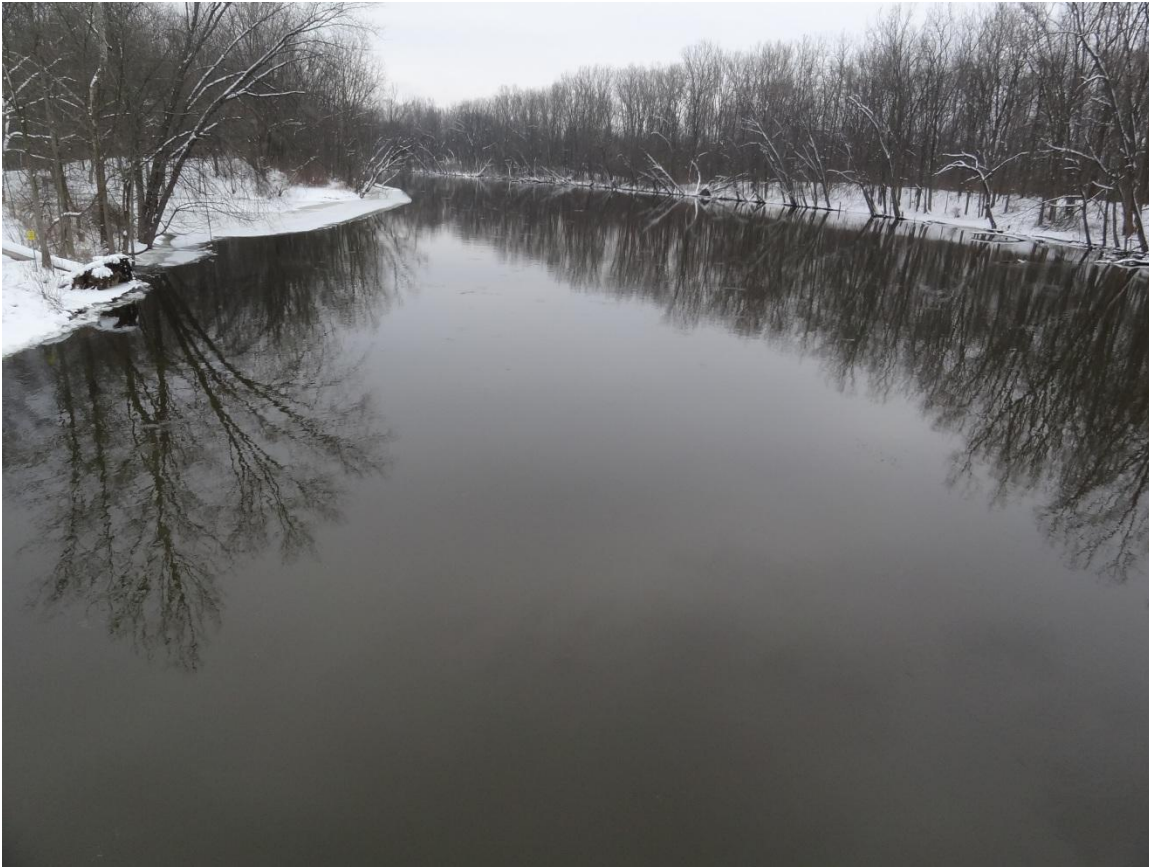
17. MP21.50 observed river icing conditions.

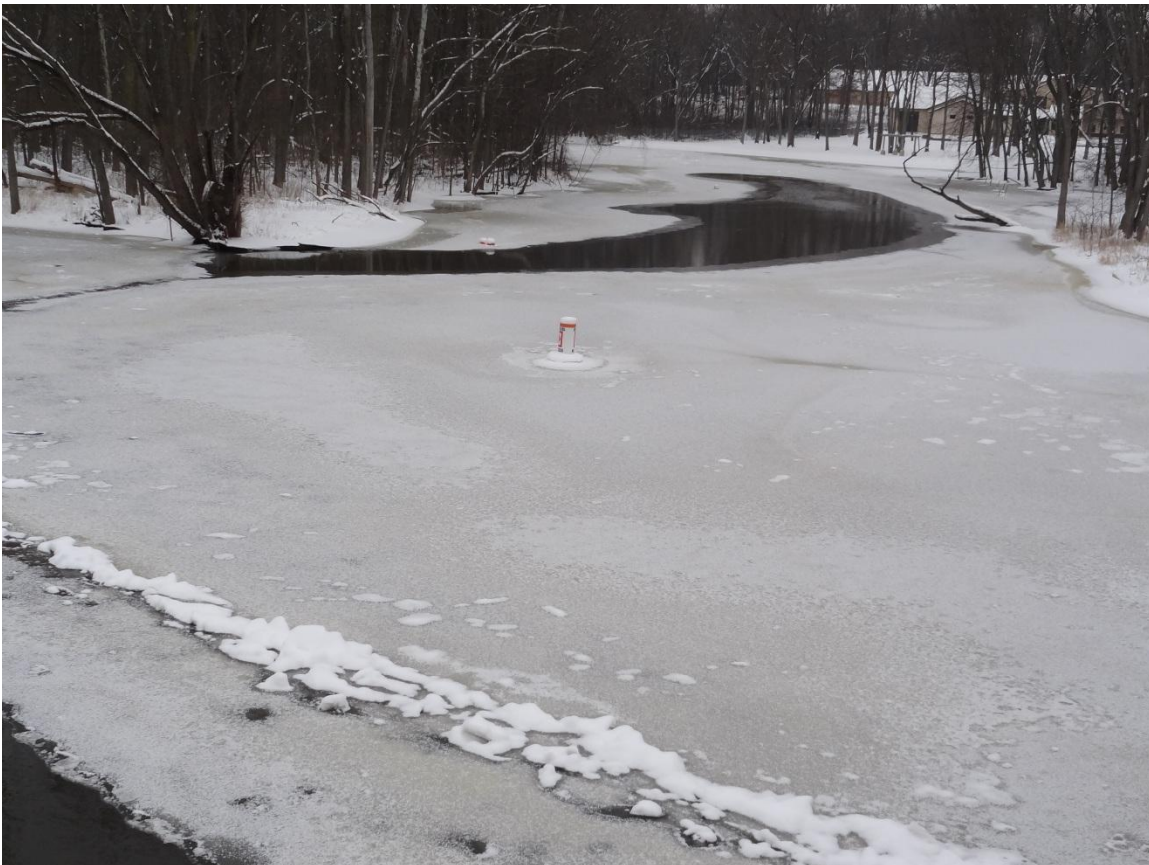
18. MP21.50 Oxbow observed icing conditions.

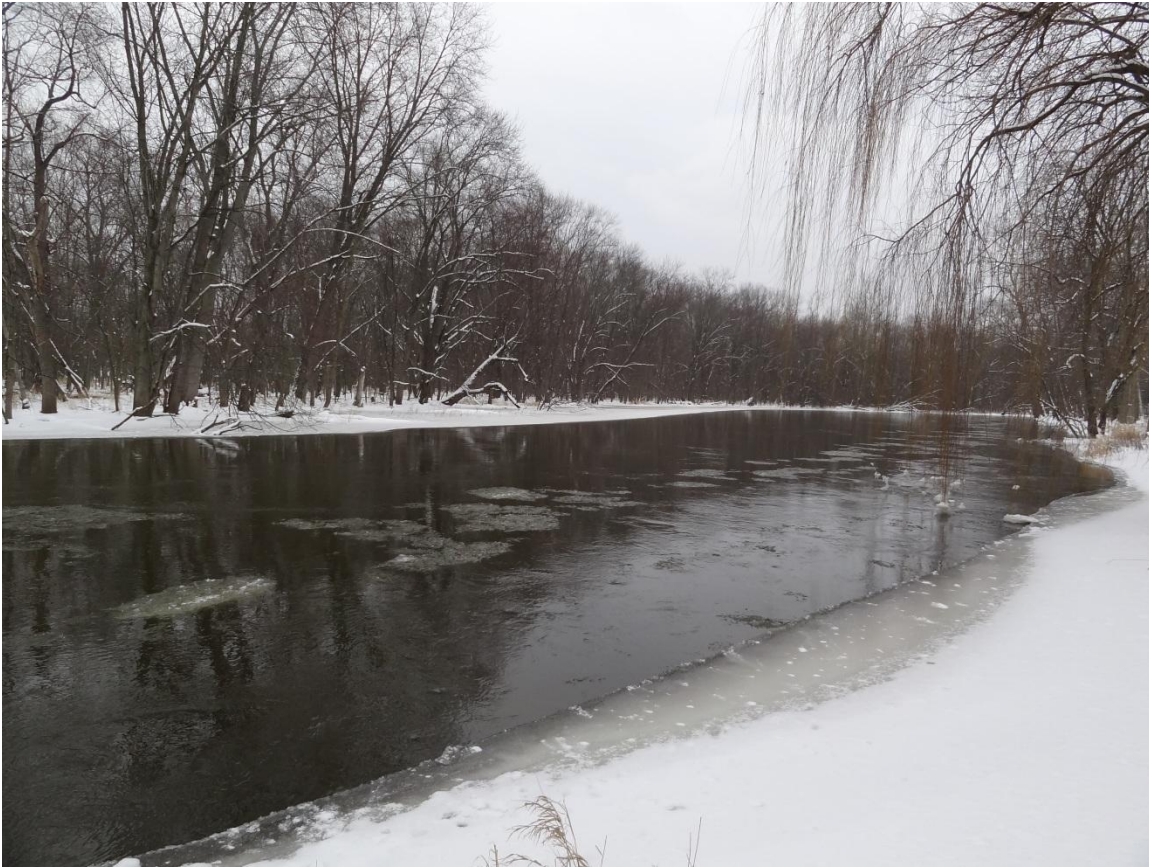
19. MP27.00 Shady Bend Campground observed river icing conditions.

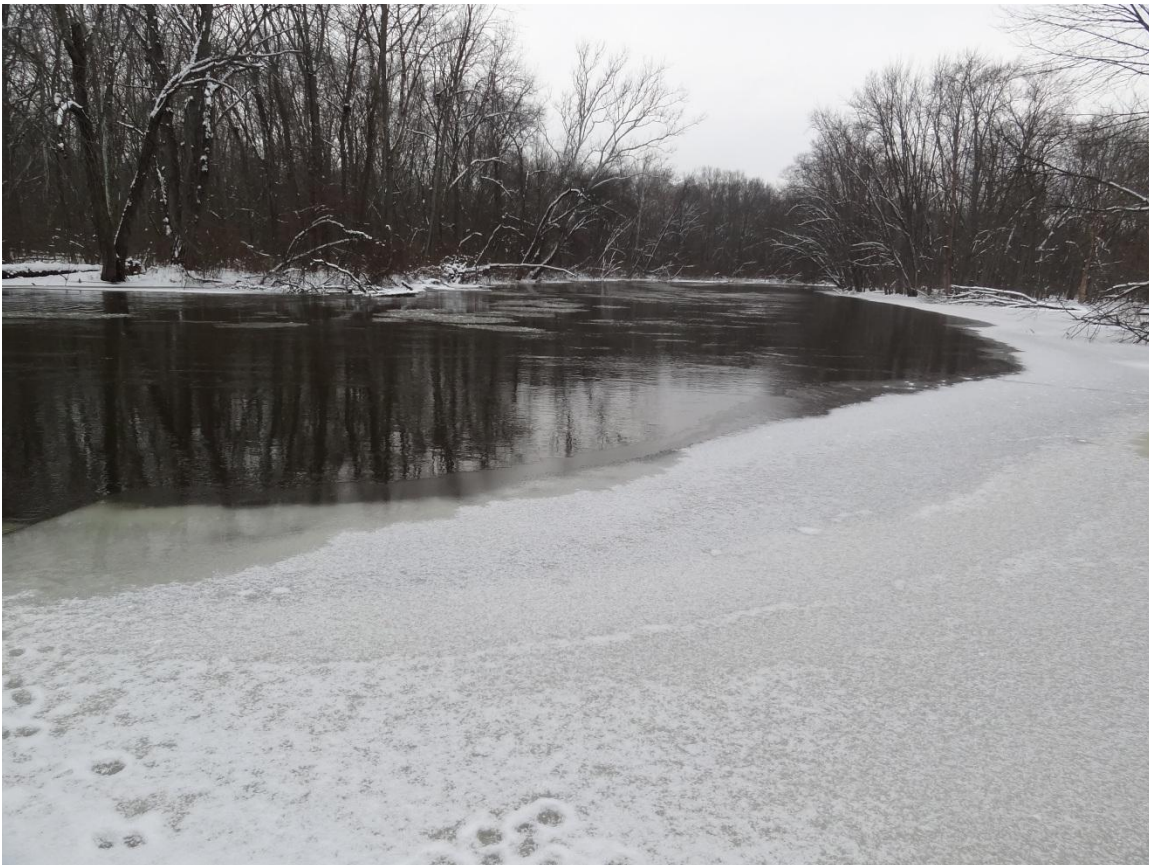
20. E2 Boat Launch observed river icing conditions.

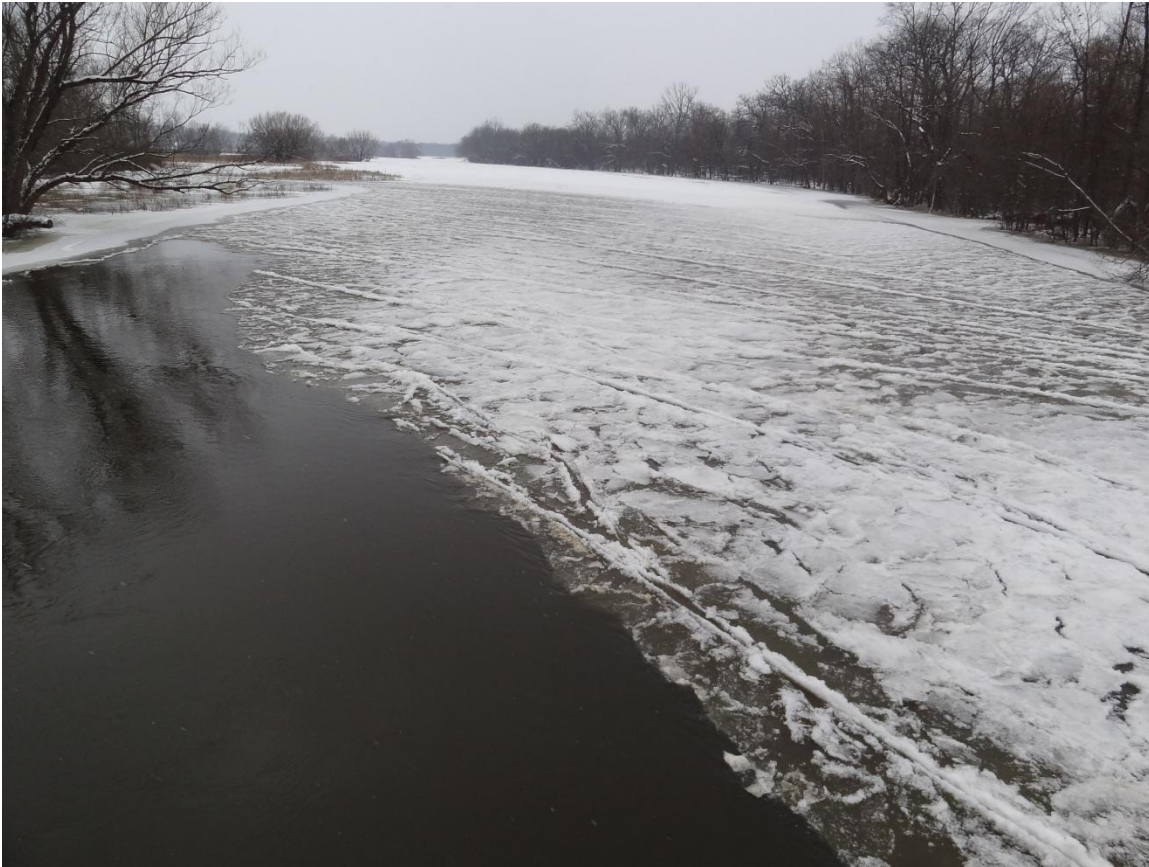
21. MP36.50 downstream from 35th Bridge observed icing conditions.

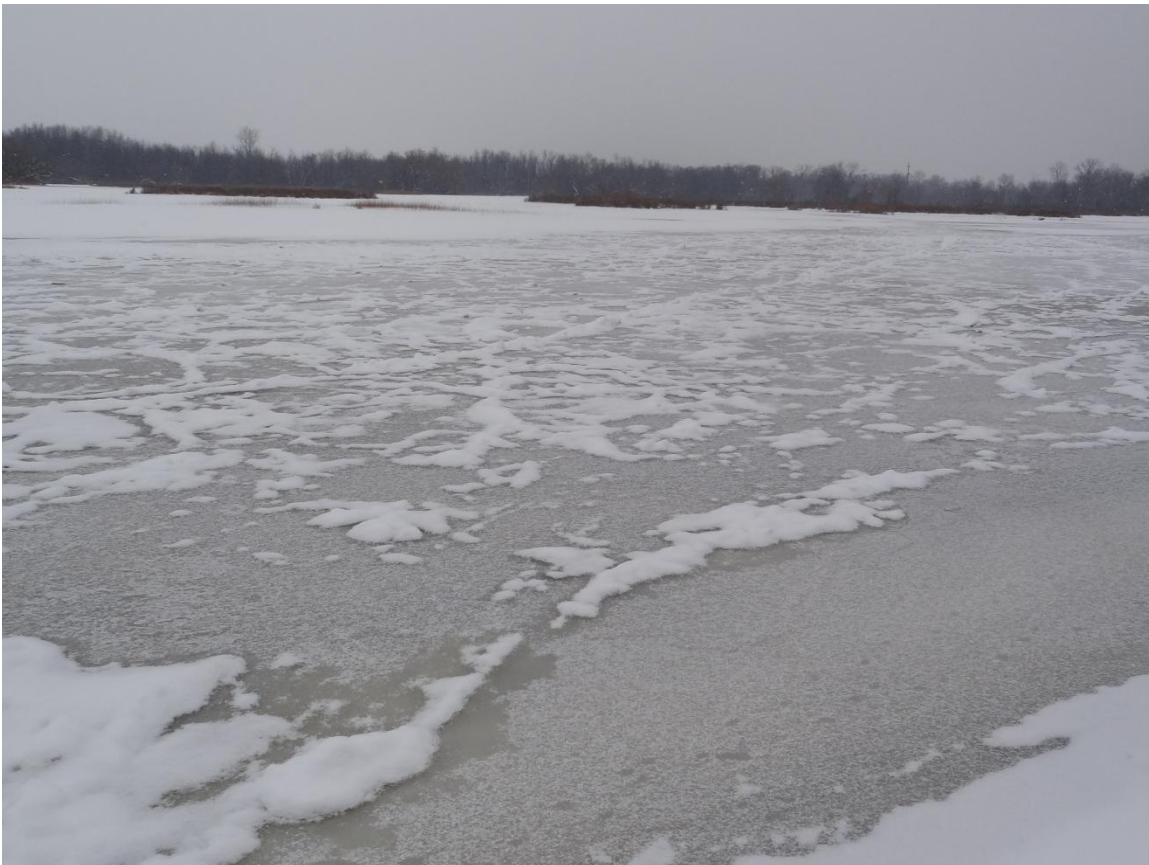
22. Morrow Lake Delta observed icing conditions.

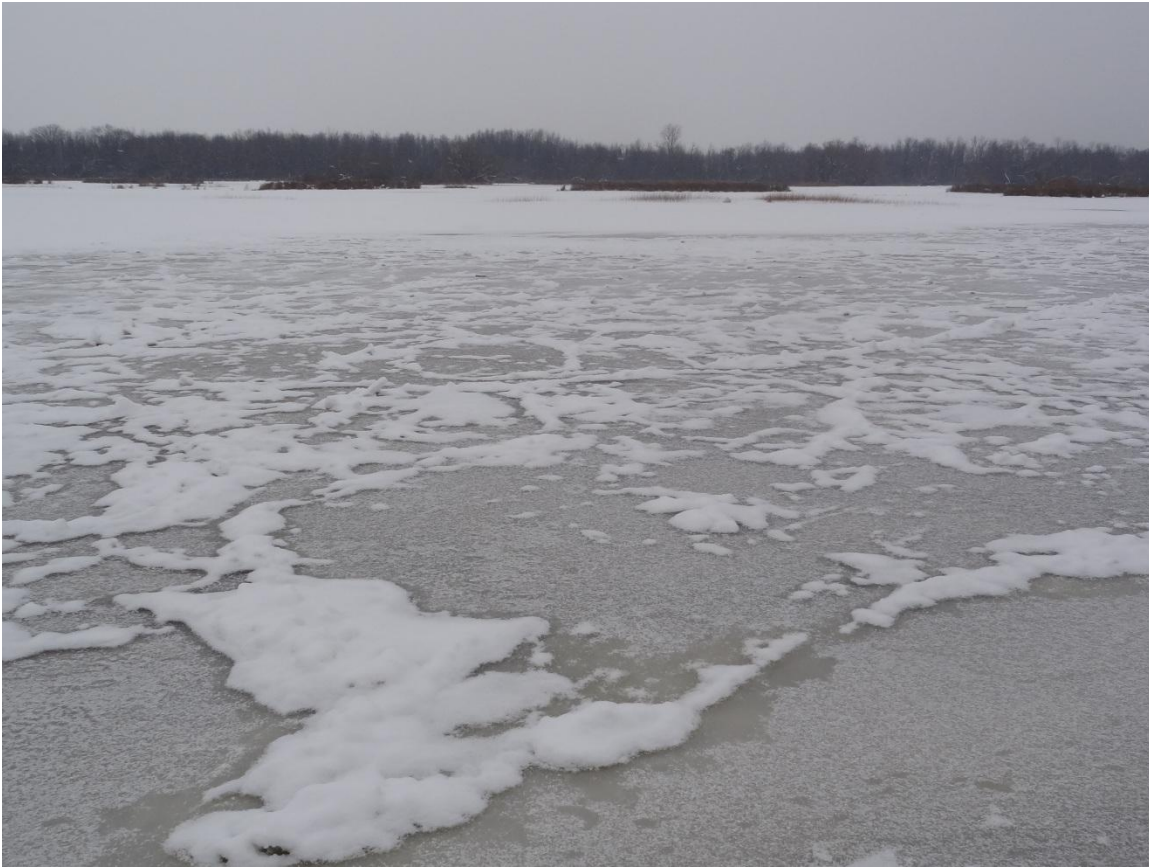
23. Morrow Lake Delta observed icing conditions.
